**Sample Thermography Inspection at**

**ABC Company**

**December 2007**

**Pumptec Diagnostics**

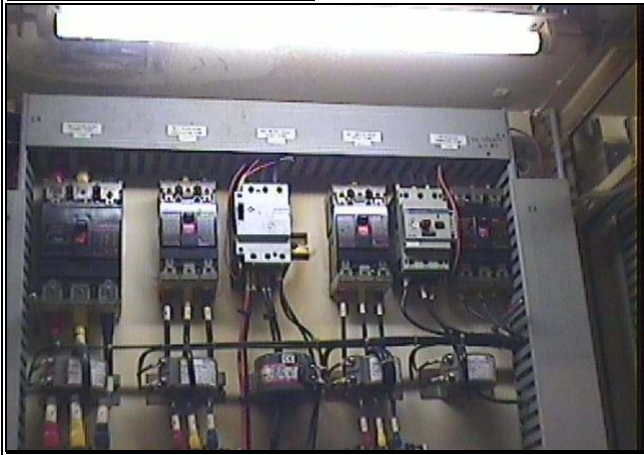
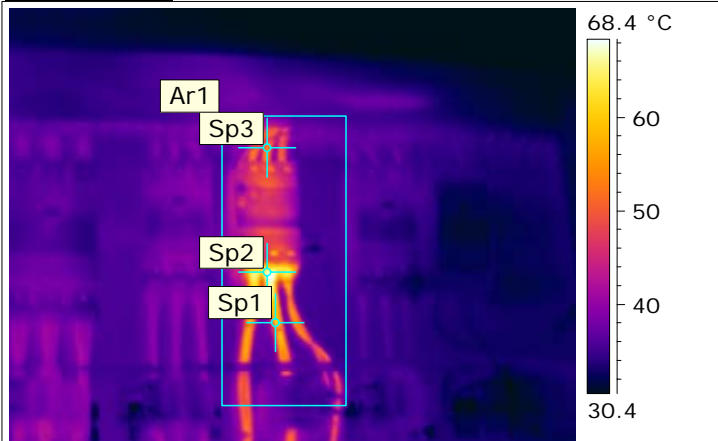
Location	Ground Floor
Equipment	Panel 1
Type	Contactors
Fault	Loose Connection
Recommendation	Strip, Clean and re-make connection
Fault Code	<b>Yellow</b>

Sp1 Temperature	60.0 °C
Sp2 Temperature	69.5 °C
Sp3 Temperature	54.3 °C
Ar1 Max. Temperature	70.8 °C

There seems to be a temperature difference on the connections at the bottom of the contactor than the top. We recommend to strip, clean and re-make all the connections to this contactor, at the next available opportunity.

(Hot Water Rinse Spray Pump Contactor)

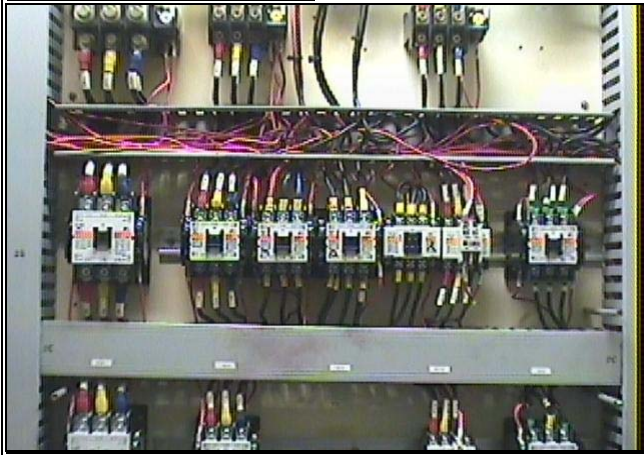
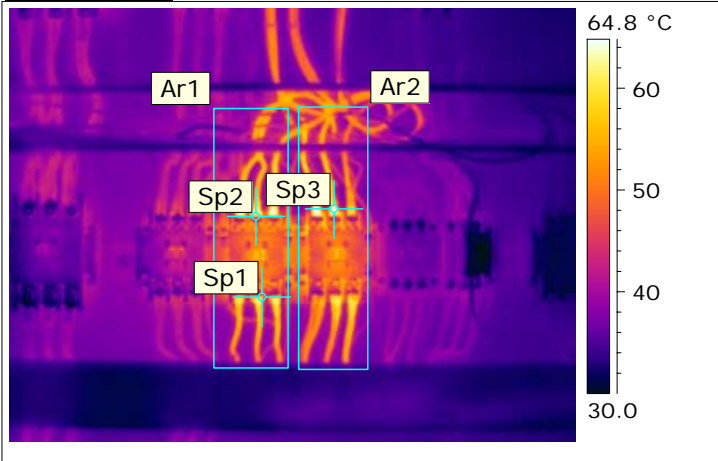
Location	Ground Floor
Equipment	Panel 2
Type	Contactors
Fault	Load
Recommendation	Check Load
Fault Code	<b>Yellow</b>

Sp1 Temperature	57.2 °C
Sp2 Temperature	47.5 °C
Sp3 Temperature	65.4 °C
Ar1 Max. Temperature	65.6 °C
Ar2 Max. Temperature	66.5 °C

The contactors shown in Ar1 box and Ar2 box are at a higher temperature than the rest of the contactors which shows a possible load problem. We would recommend to check the load at the next available opportunity.

The contactors are marked with an X1 and X2
