**Sample Thermography Inspection at**

**ABC Company**

**December 2007**

**Pumptec Diagnostics**

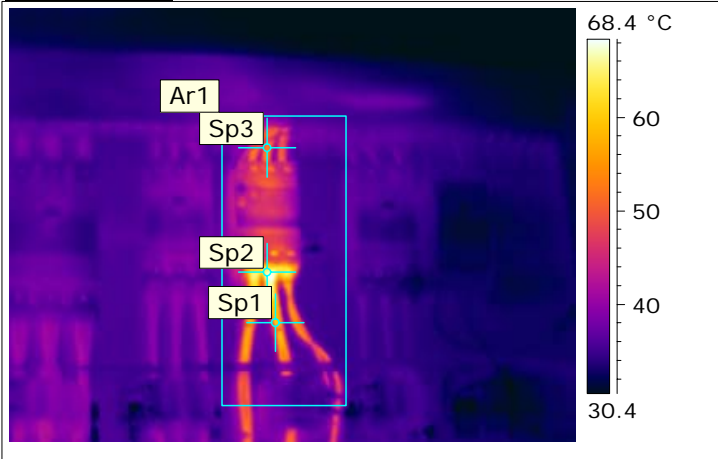
Location	Ground Floor
Equipment	Panel 1
Type	Contactors
Fault	Loose Connection
Recommendation	Strip, Clean and re-make connection
Fault Code	<b>Yellow</b>

Sp1 Temperature	60.0 °C
Sp2 Temperature	69.5 °C
Sp3 Temperature	54.3 °C
Ar1 Max. Temperature	70.8 °C

There seems to be a temperature difference on the connections at the bottom of the contactor than the top. We recommend to strip, clean and re-make all the connections to this contactor, at the next available opportunity.

(Hot Water Rinse Spray Pump Contactor)

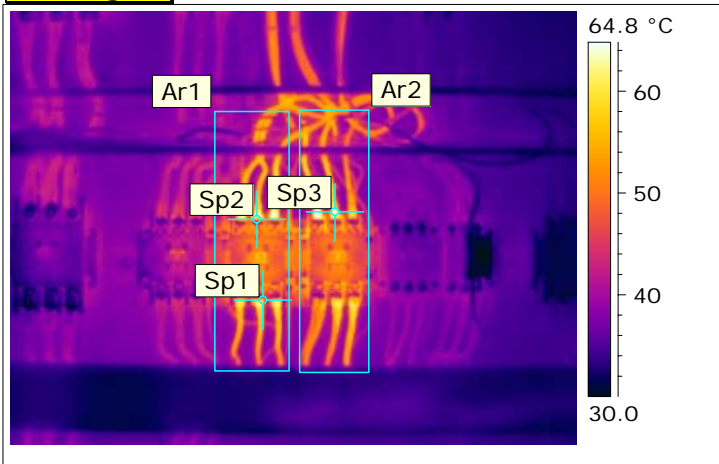
Location	Ground Floor
Equipment	Panel 2
Type	Contactors
Fault	Load
Recommendation	Check Load
Fault Code	<b>Yellow</b>

Sp1 Temperature	57.2 °C
Sp2 Temperature	47.5 °C
Sp3 Temperature	65.4 °C
Ar1 Max. Temperature	65.6 °C
Ar2 Max. Temperature	66.5 °C

The contactors shown in Ar1 box and Ar2 box are at a higher temperature than the rest of the contactors which shows a possible load problem. We would recommend to check the load at the next available opportunity.

The contactors are marked with an X1 and X2
