Vibration Analysis Sample Survey at

ABC Company

Weekly Monitored Items

29 January 2008

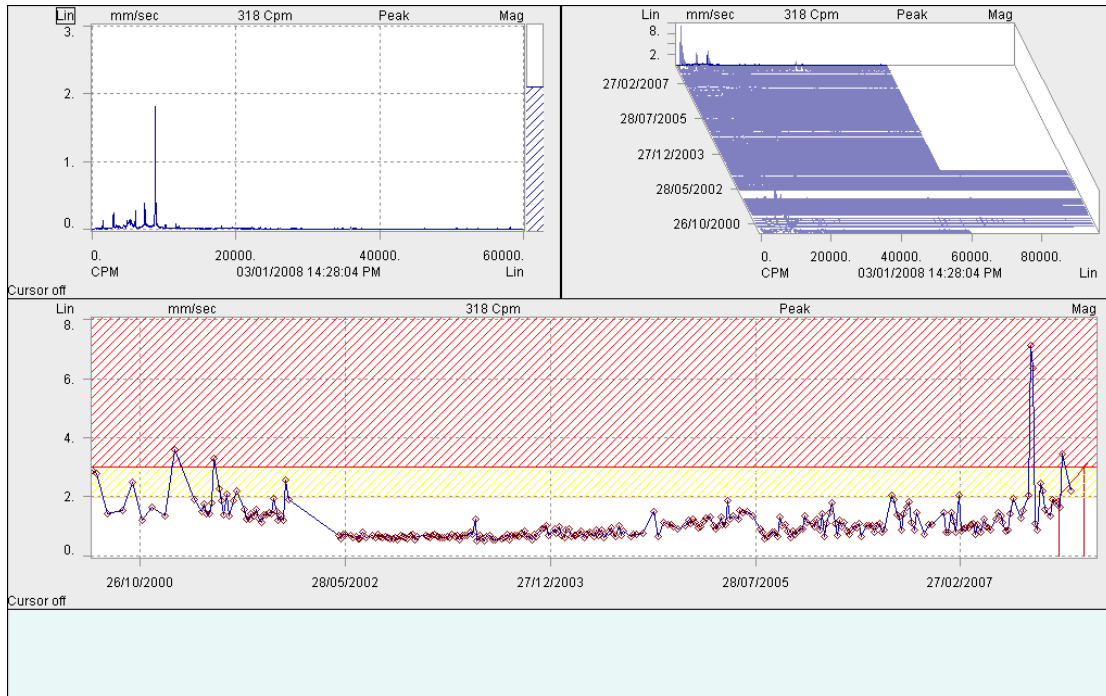
Location	Plant 1
Unit	Item 14
Position	Pump Non-Drive End
Direction	Horizontal
Fault Code	RED(3)

There is a large amount of vibration coming from the Pump NDE at rotating speed, This Vibration is increasing. This is due to the bearings starting to fail. It is currently recommended to change the Pump Bearings for new.
